SNX 200/400/RS, SNX 200/400/RM SYSTEMA (LARK)

CHARACTERISTICS

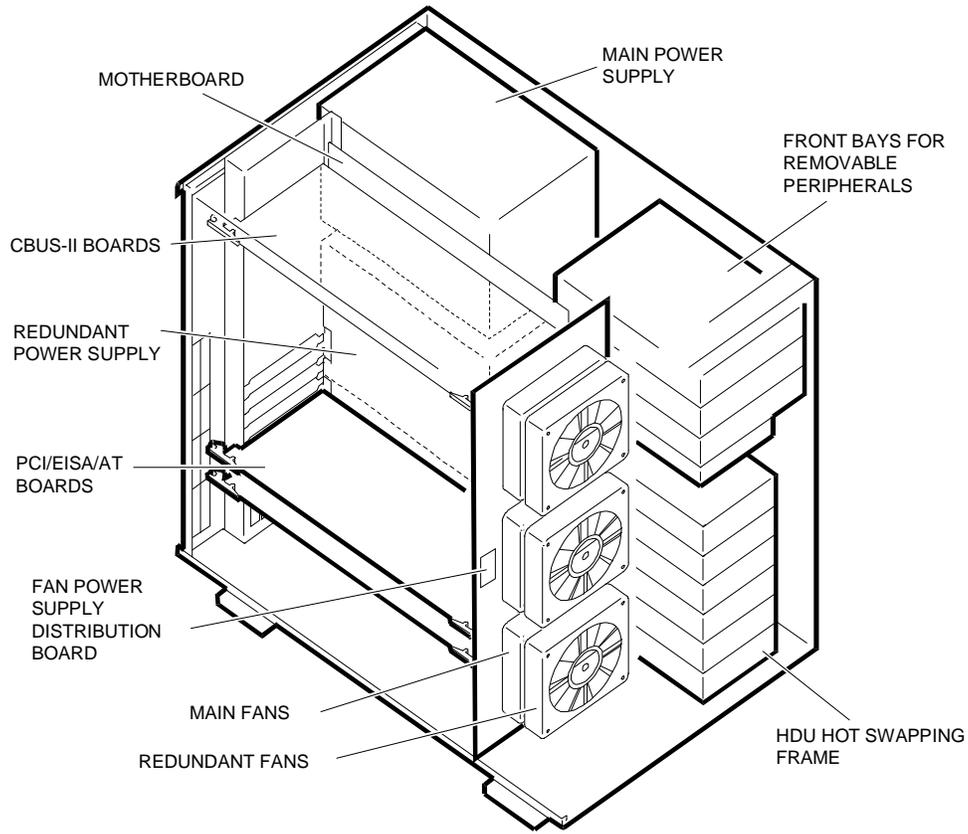
SNX 200/RS AND SNX 400/RS BASIC MODULE

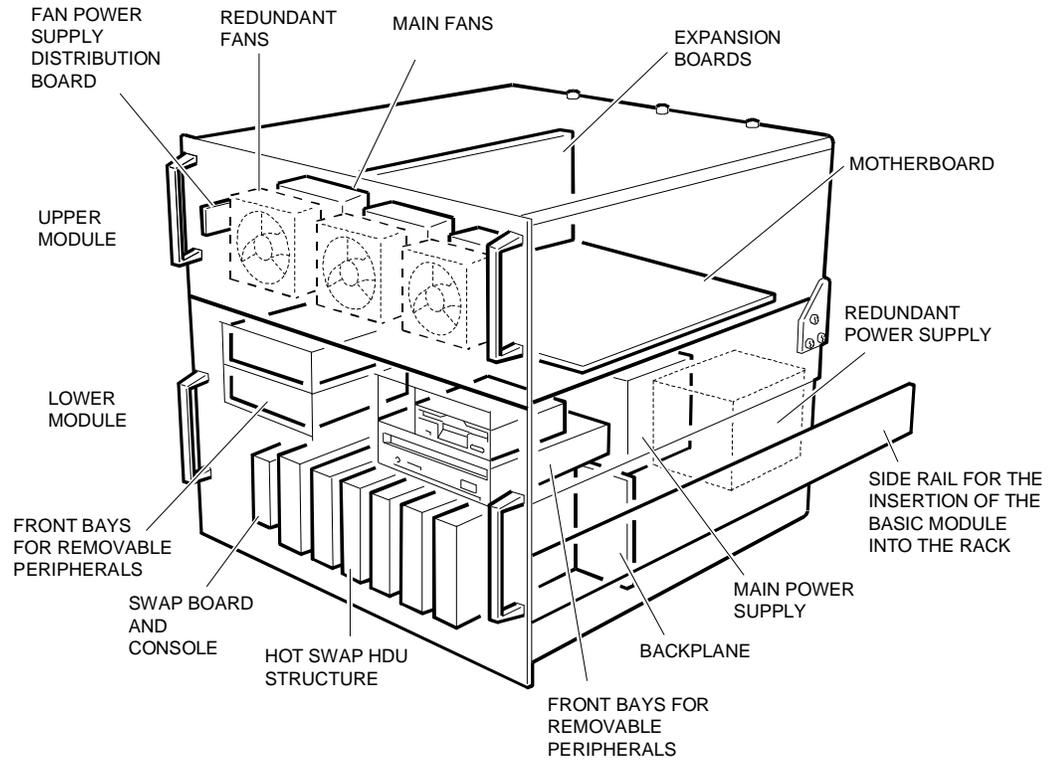
SNX 200/RM AND SNX 400/RM BASIC MODULE

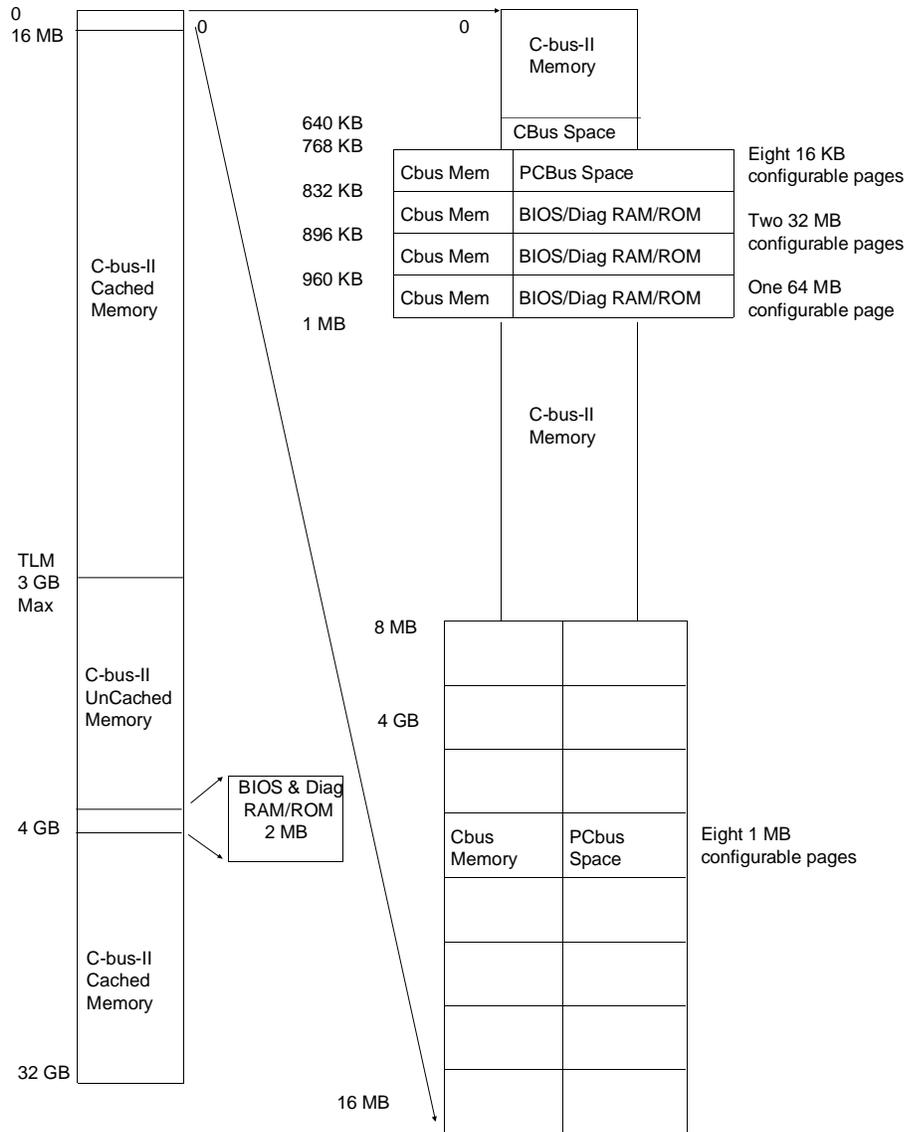
SYSTEM MEMORY MAP

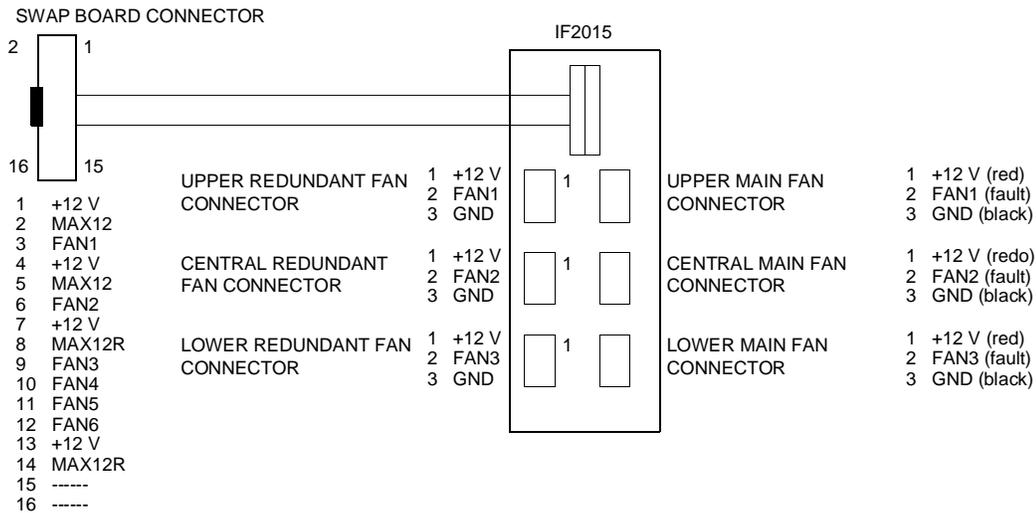
The redundant and main fans are connected through the IF2015 fan power distribution board.

From March 1996 the B19 fan assembly (code 589375G) is replaced by fans NMB 4715KL-04W-26 called B26 (code 564151 W). Fans B26 are equipped with an internal temperature sensor so that they turn slowly at normal environmental temperatures, increasing their speed of rotation as the temperature increases. These fans are compatible with Swap Board IF2012 Lev. 03S1 or IF2031 Lev. 02 and later updates. The main and redundant fans operate in the same way as the B19 fans.

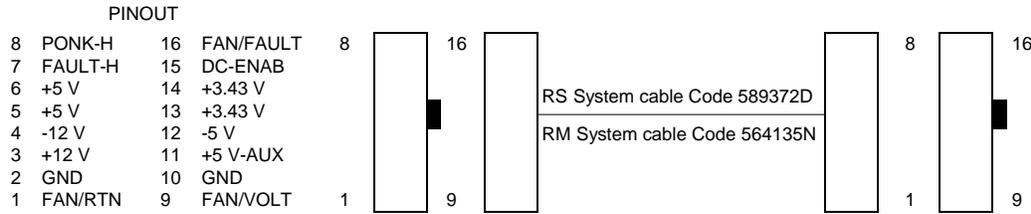
Motherboard-IF2025 Power Supply Parallelism Board Connection Cable

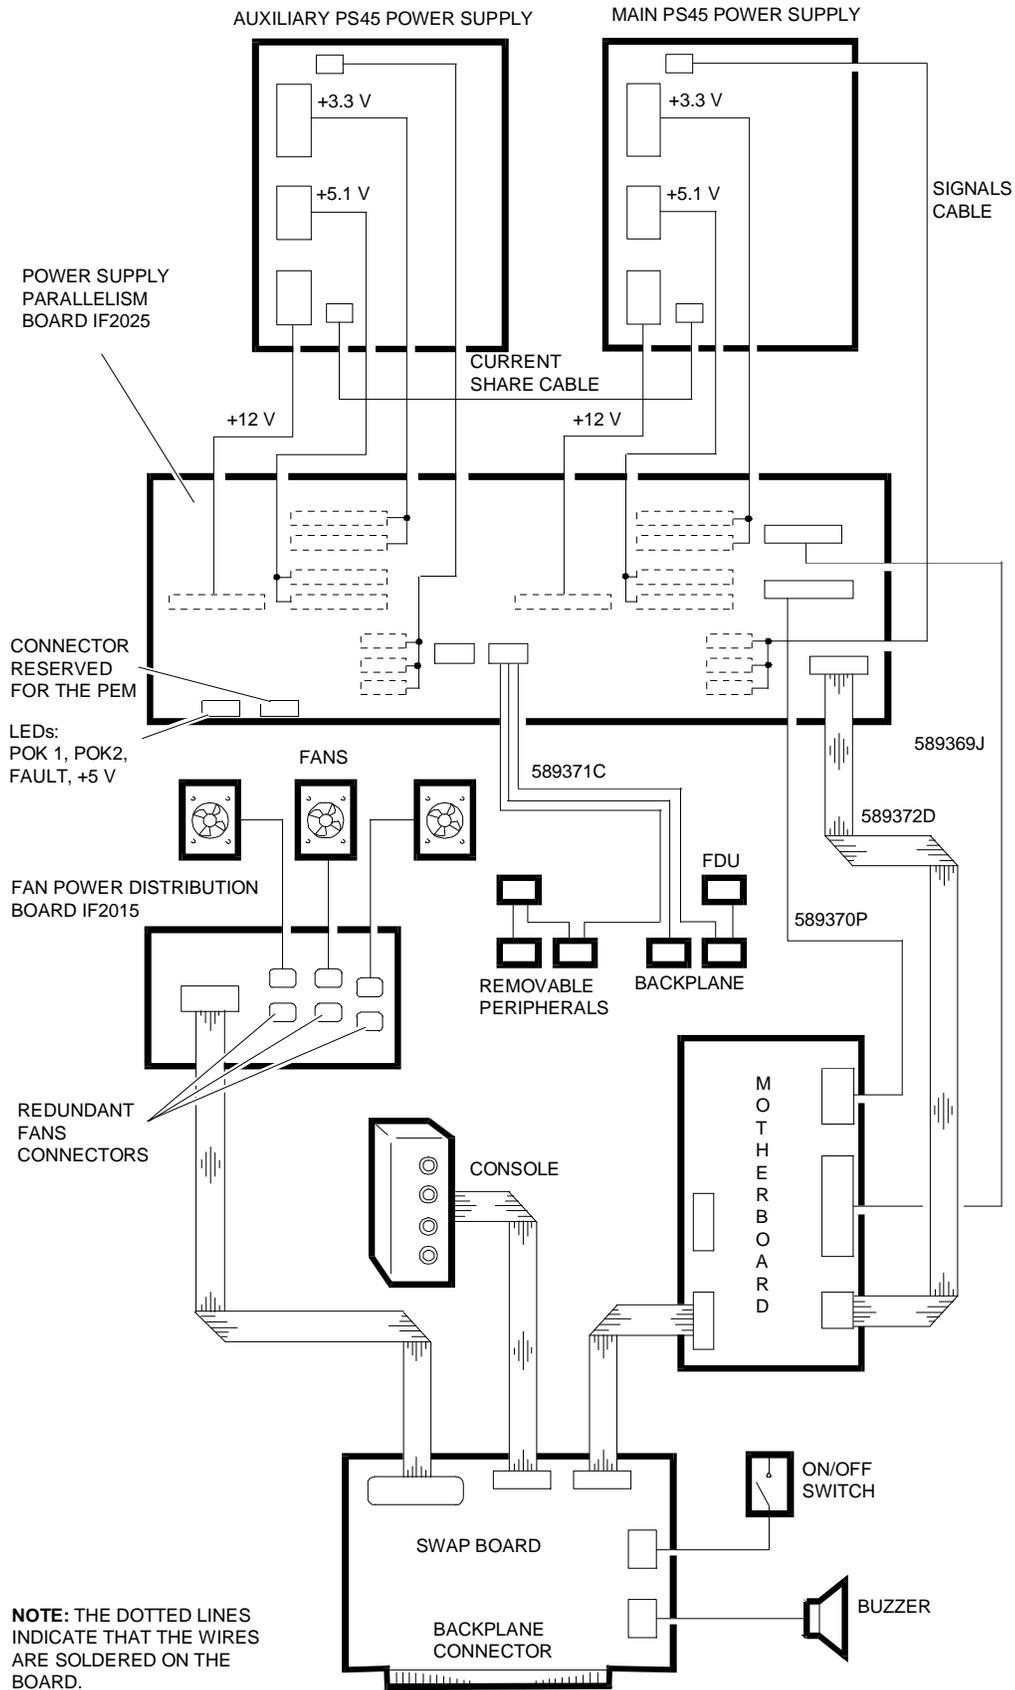
ELECTRICAL CONNECTIONS ON REDUNDANT RS SYSTEMS

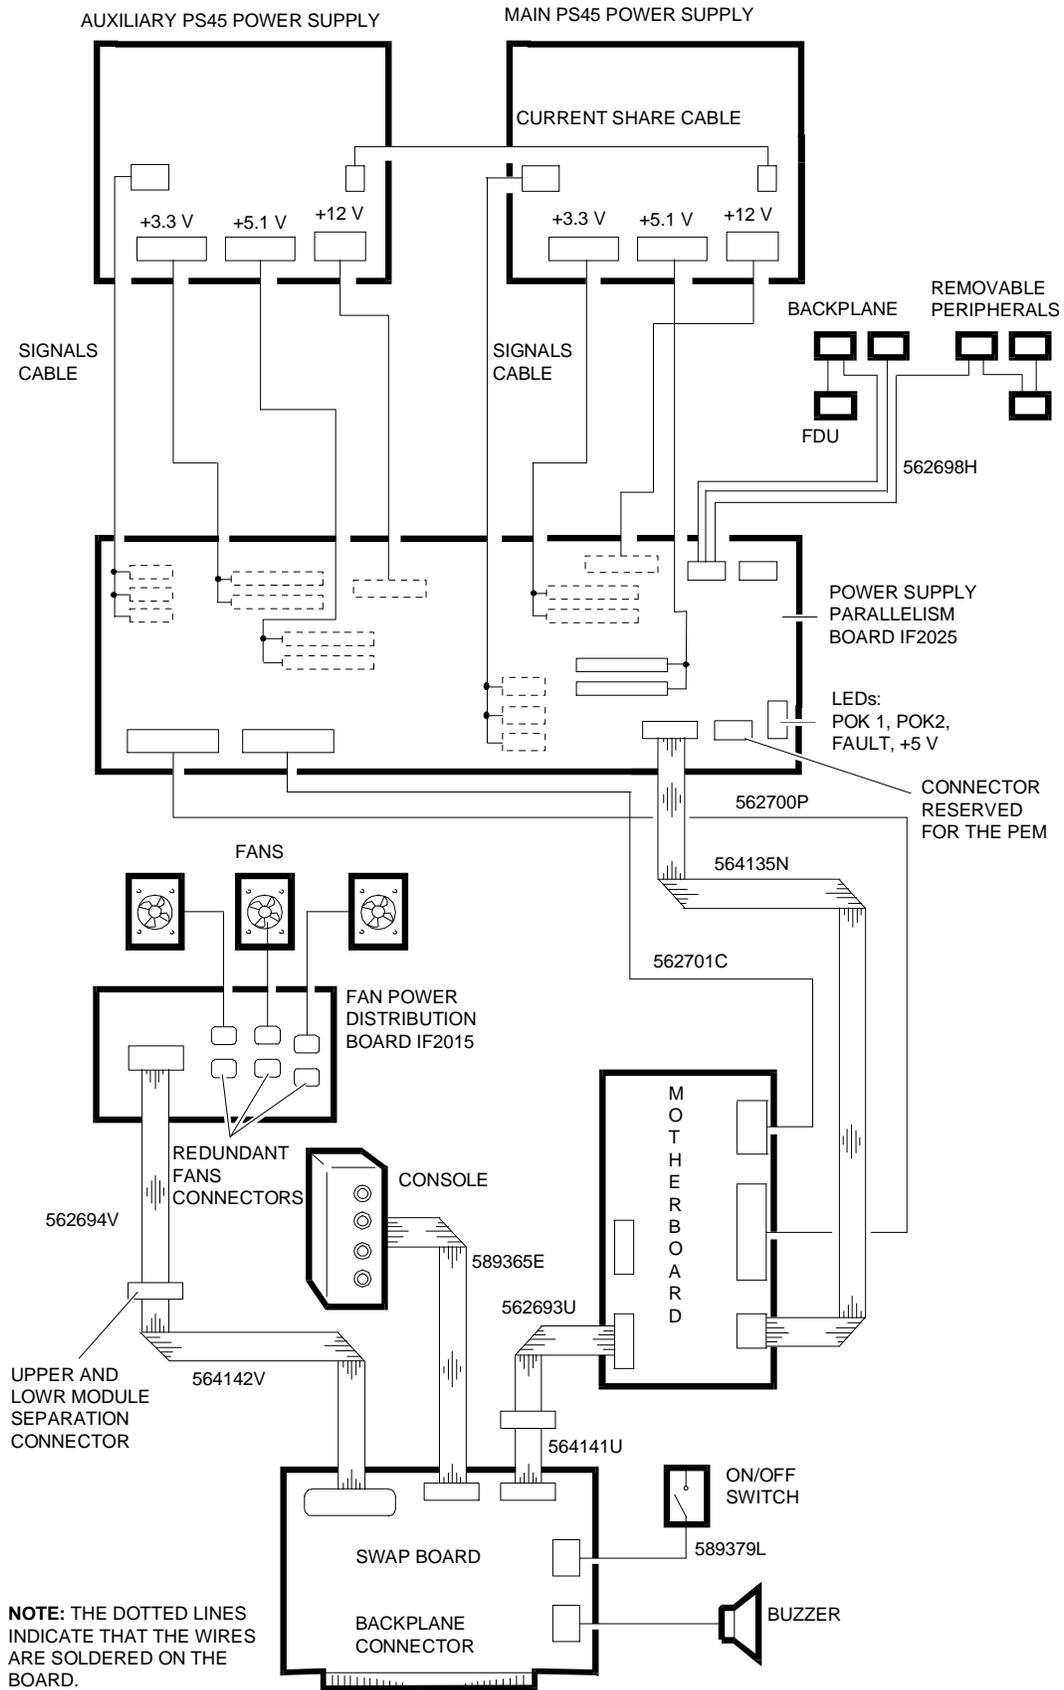
ELECTRICAL CONNECTIONS ON REDUNDANT RM SYSTEMS

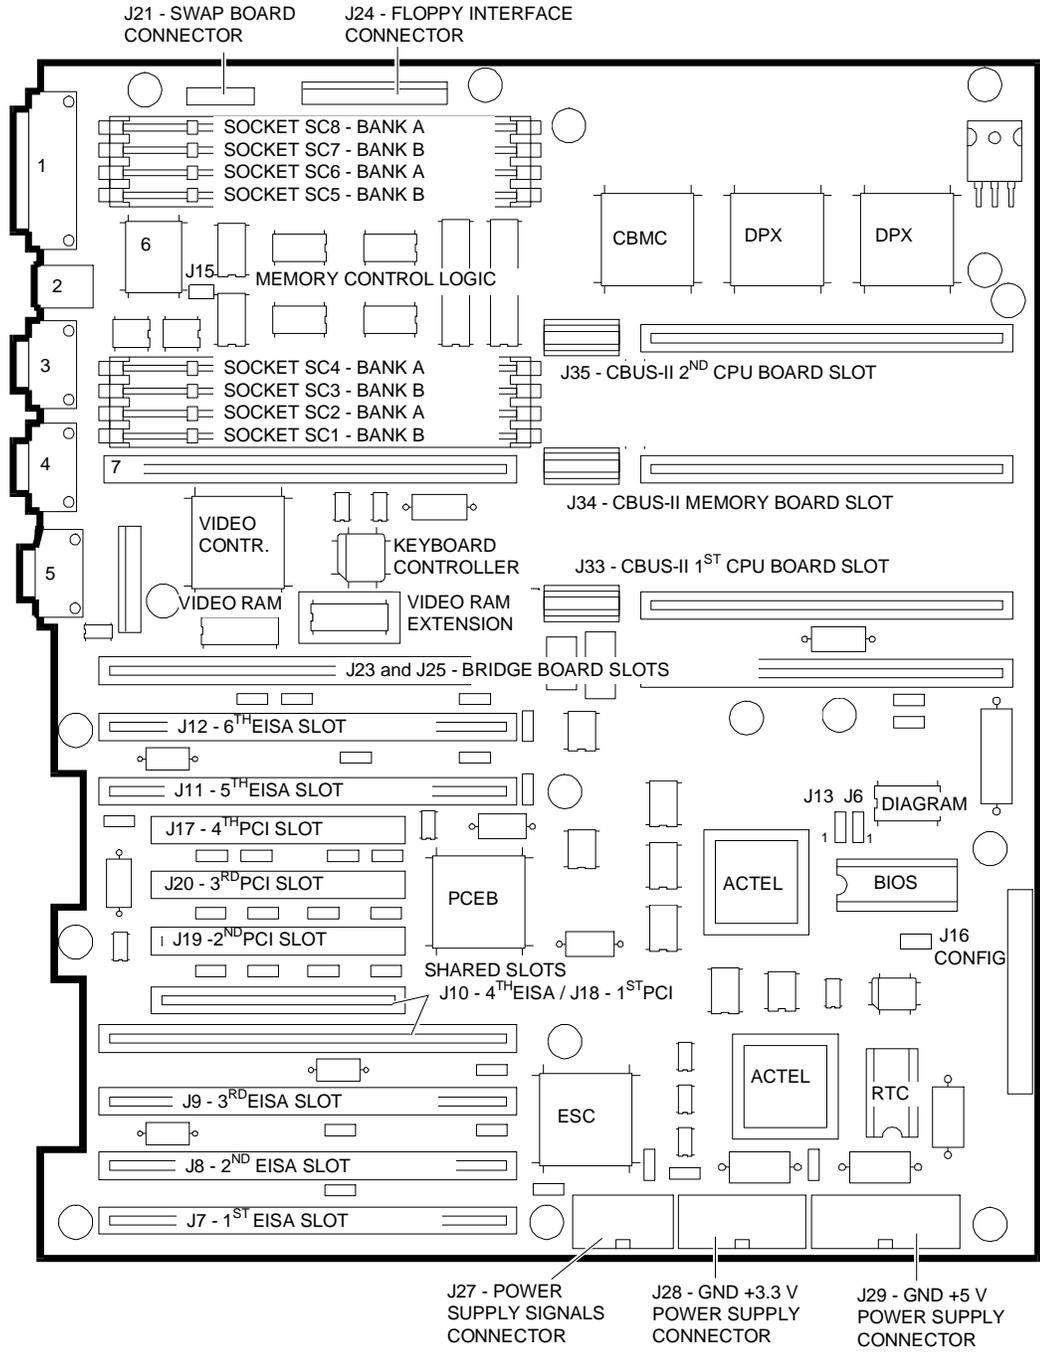
MOTHERBOARD BA2179 / 2193 / 2241 (FOR THE SNX 200)

- 1 Parallel interface connector
- 2 Keyboard connector (above), mouse connector (under)
- 3 Serial interface connector (COM1)
- 4 Serial interface connector (COM2)
- 5 VGA video interface connector
- 6 Floppy disk controller, serial and parallel interfaces
- 7 Connector J36 - not used

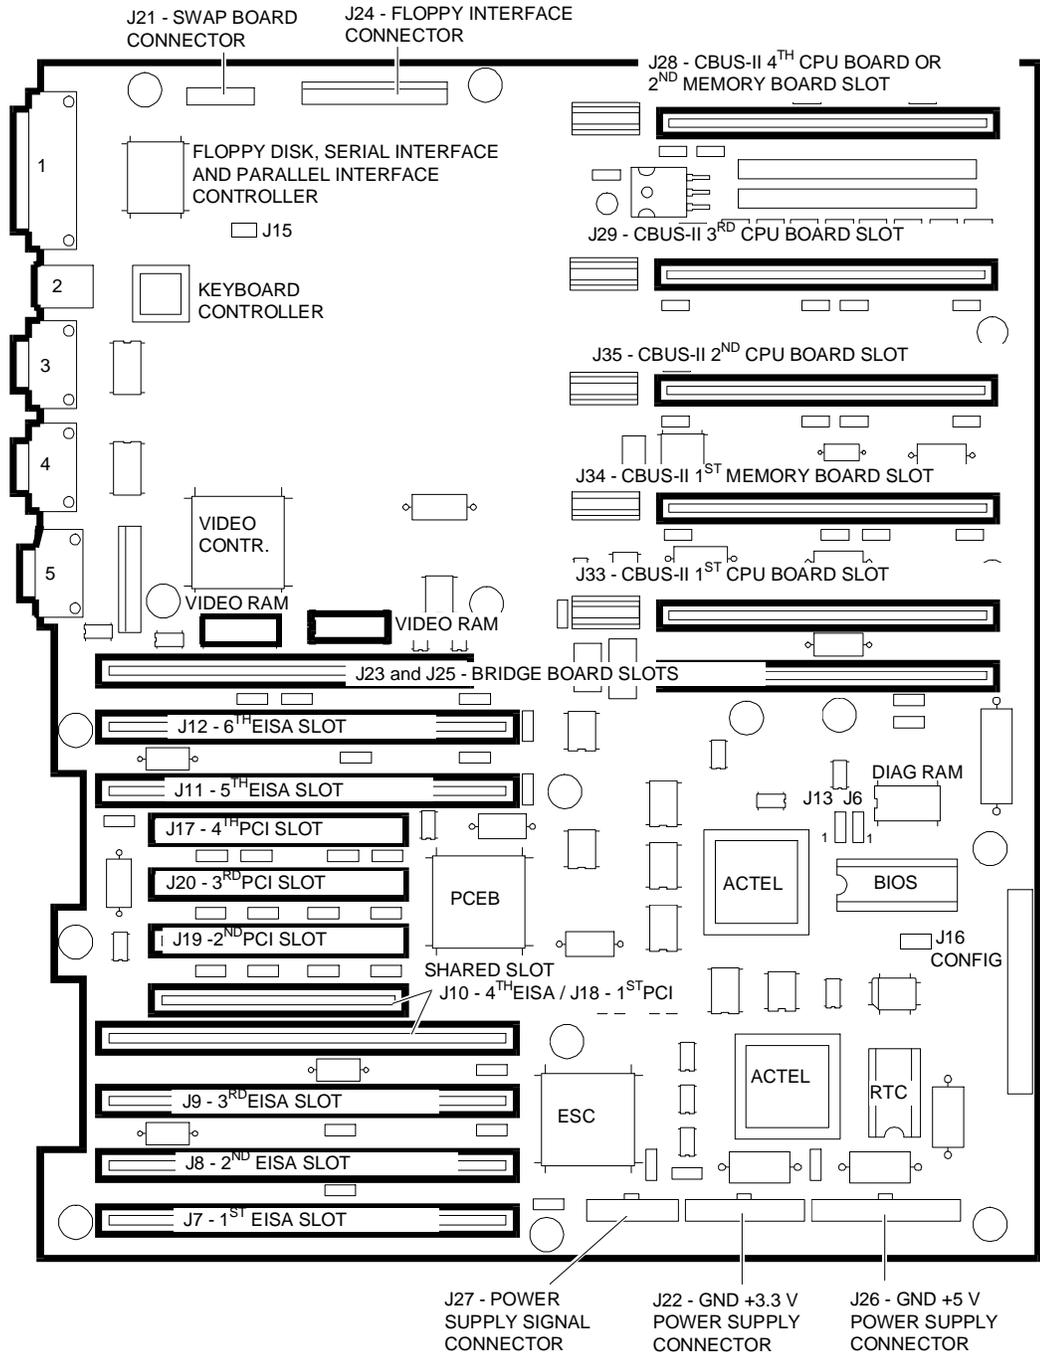
MOTHERBOARD BA2178 / BA2236 (FOR THE SNX 400)

- 1 Parallel interface connector
- 2 Keyboard connector (above), mouse connector (below)
- 3 Serial interface connector (COM1)
- 4 Serial interface connector (COM2)
- 5 VGA video interface connector

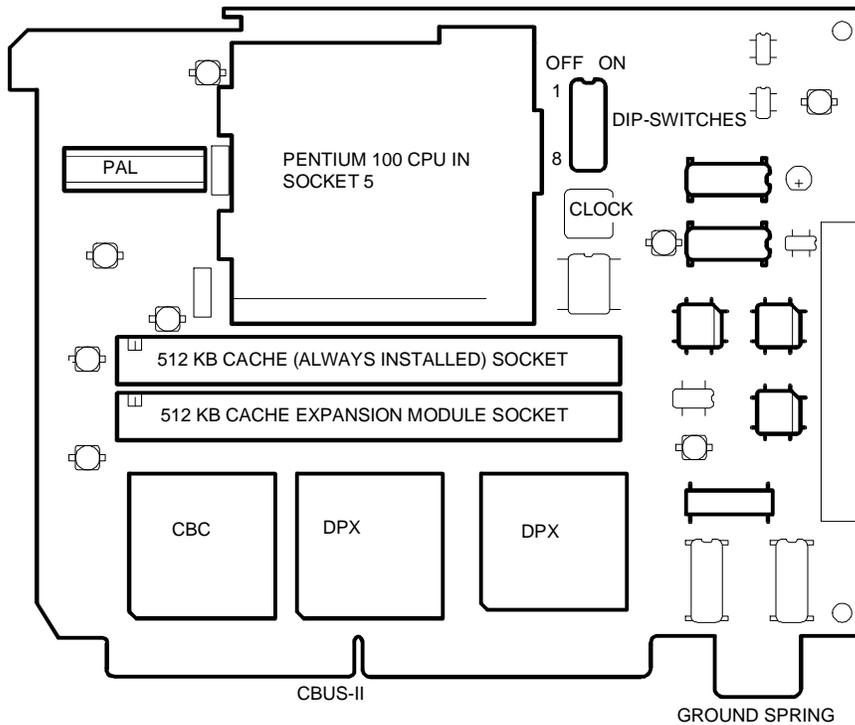
CPU BOARD GO2056 / GO2071 (SNX 200/RS/RM 100) GO2078 (SNX 400/RS/RM 100)

The second level cache consists of a SIMM installed in a specific socket. A 512 KB (1 SIMM) basic memory capacity is always present and can be expanded to 1 MB by installing a second SIMM into the adjacent slot. The DIP-switches need to be set depending on the cache memory capacity.

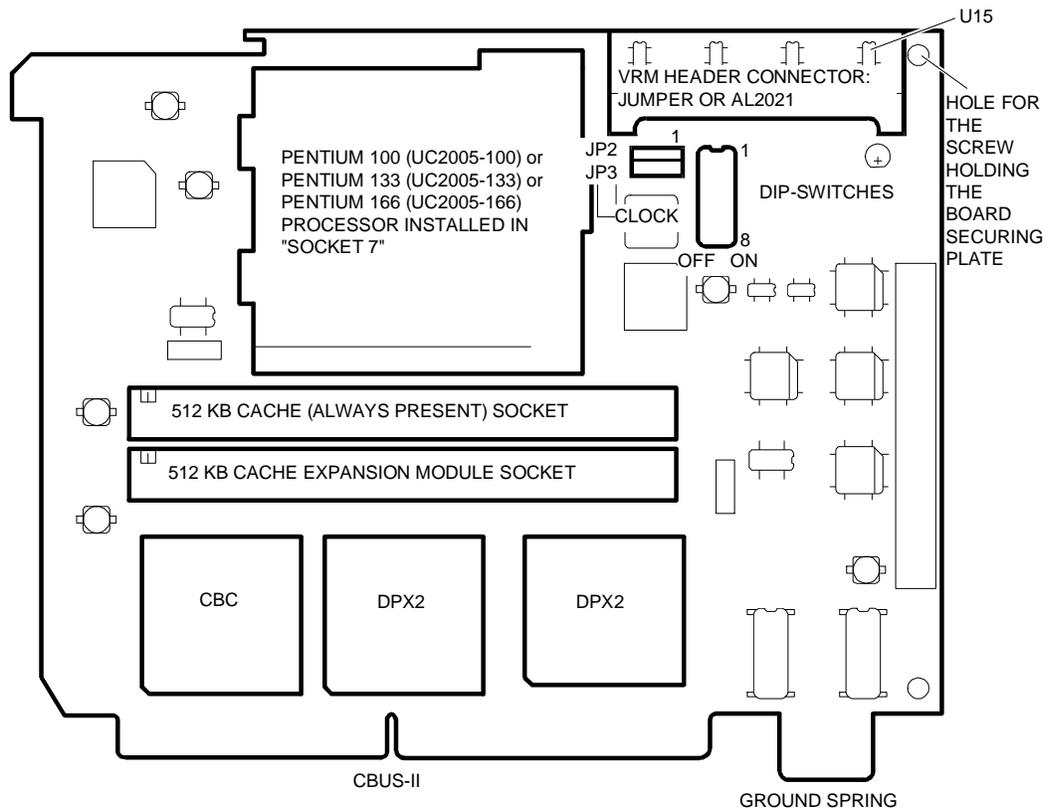
CPU BOARDS UC2004/2005-100 (SNX 200/400/RS/RM 100) UC2004/2005-133 (SNX 200/400/RS/RM 133 AND 400 133 W) UC2005-166 (SNX 400/RS/RM 166 W)

Note: The name of board UC2004/2005 remains unchanged for the 100, 133 and 166 MHz version. For simplicity, this guide distinguishes between the three versions with UC200X-100, UC200X-133 and UC200X-166.

The 66.67/100 MHz CPU board UC200X-100 is an evolution of the previous GO2071/2078 CPU board models. This new board comes in a single version, is compatible with the SNX 200 and SNX 400 and replaces the previous board versions.

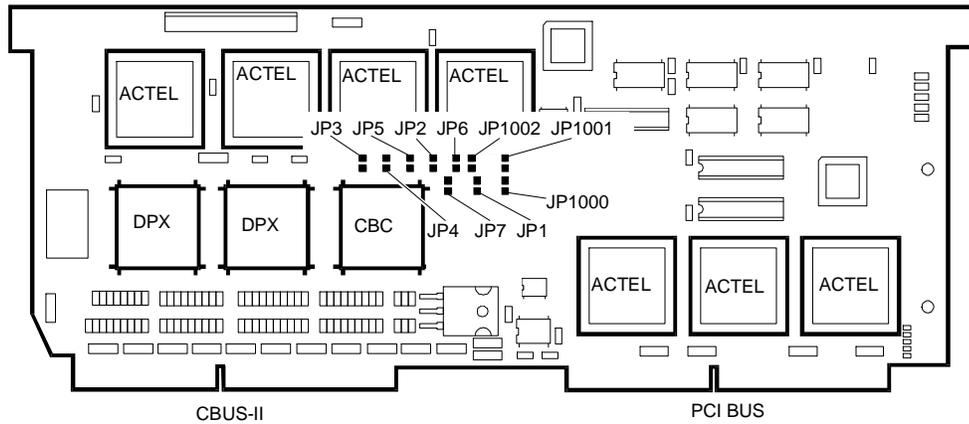
CBUS-II - PCI BRIDGE BOARD IF2018 / IF2039

Note: This board uses discrete ACTEL components.

JUMPERS (default)				
JP3 = OFF	JP4 = OFF	JP5 = OFF	JP2 = OFF	JP6 = OFF
JP1002 = ON	JP1001 = OFF	JP1000 = OFF	JP7 = OFF	JP1 = OFF

Note: These jumper settings must never be changed; they must be kept to their default setting.

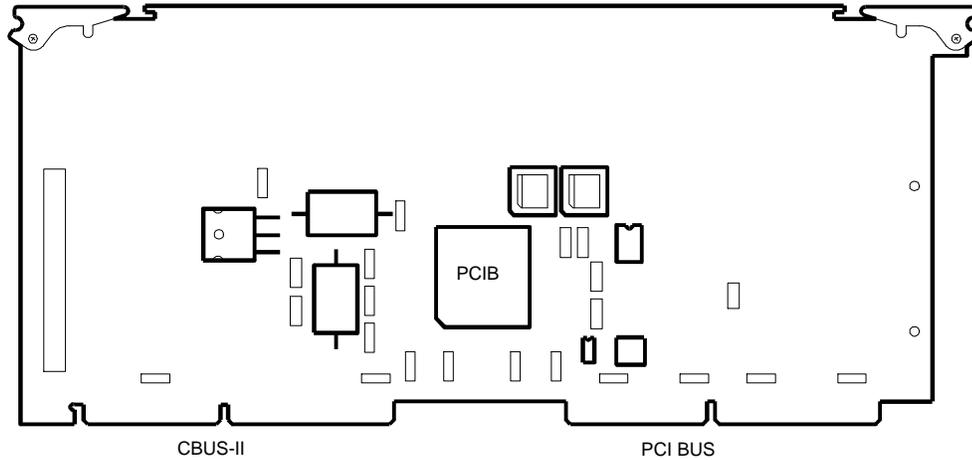
CBUS-II - PCI BRIDGE ASIC BOARD IF2037/IF2044

Note: This board uses a single ASIC component which replaces the discrete ACTEL components. Board functions remain the same.

Note: There are no jumpers on this board.

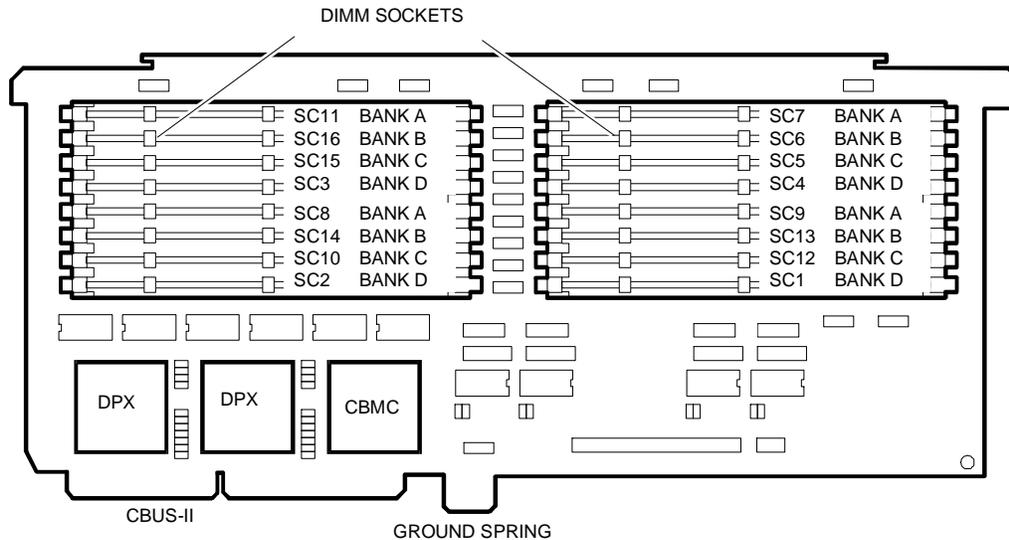
MEMORY BOARD ME2037

This memory board is optional for the SNX 200 since part of this system's memory already resides on the motherboard. For the SNX 400, instead, at least one memory board must be installed since the motherboard on these models has no resident memory.

This memory board has a total of 16 sockets divided in to four banks and is capable of hosting ECC DIMMs (Dual In-Line Memory Modules). Listed below are the rules to follow when configuring memory:
