SNX 460/RS 460/RM SYSTEMA (CONDOR)

CHARACTERISTICS

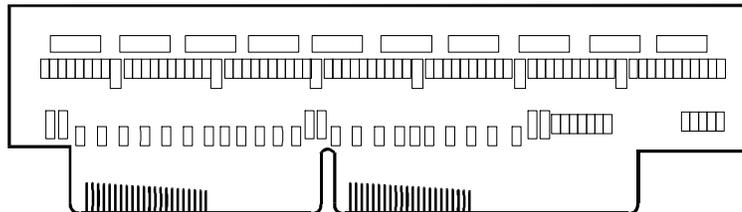
PENTIUM PRO SYSTEM BUS CONNECTOR

Board Name	Max. No. of Boards	Slot	Connector
PENTIUM PRO SYSTEM BUS			
First CPU board (always present)	1	Slot 1	J5
memory expansion board ME2047	1	Slot 2	J6
Second CPU board or system bus termination board	1	Slot 3	J4
PRIMARY PCI BUS

Full size PCI board	3	Slot 1	J20
		Slot 2	J19
		Slot 3	J12
Half size PCI board (PCI/EISA shared slot)	1	Slot 4	J13
SECONDARY PCI BUS			
Full size PCI board	3	Slot 1	J14
		Slot 3	J17
		Slot 4	J18
Half size PCI board	1	Slot 2	J16
EISA BUS (All bus master slots)			
Full size EISA board	2	Slot 1	J8
		Slot 2	J7
Full size EISA board when the 2 nd CPU board is not present Half size EISA board when the 2 nd CPU board is present	1	Slot 3	J10
Half size EISA board (PCI/EISA shared slot)	1	Slot 4	J11
