## SNX 140/S / 160/S SYSTEMA (EAGLE-2)

**SNX 140/S 160/S SYSTEMA BASIC MODULE**

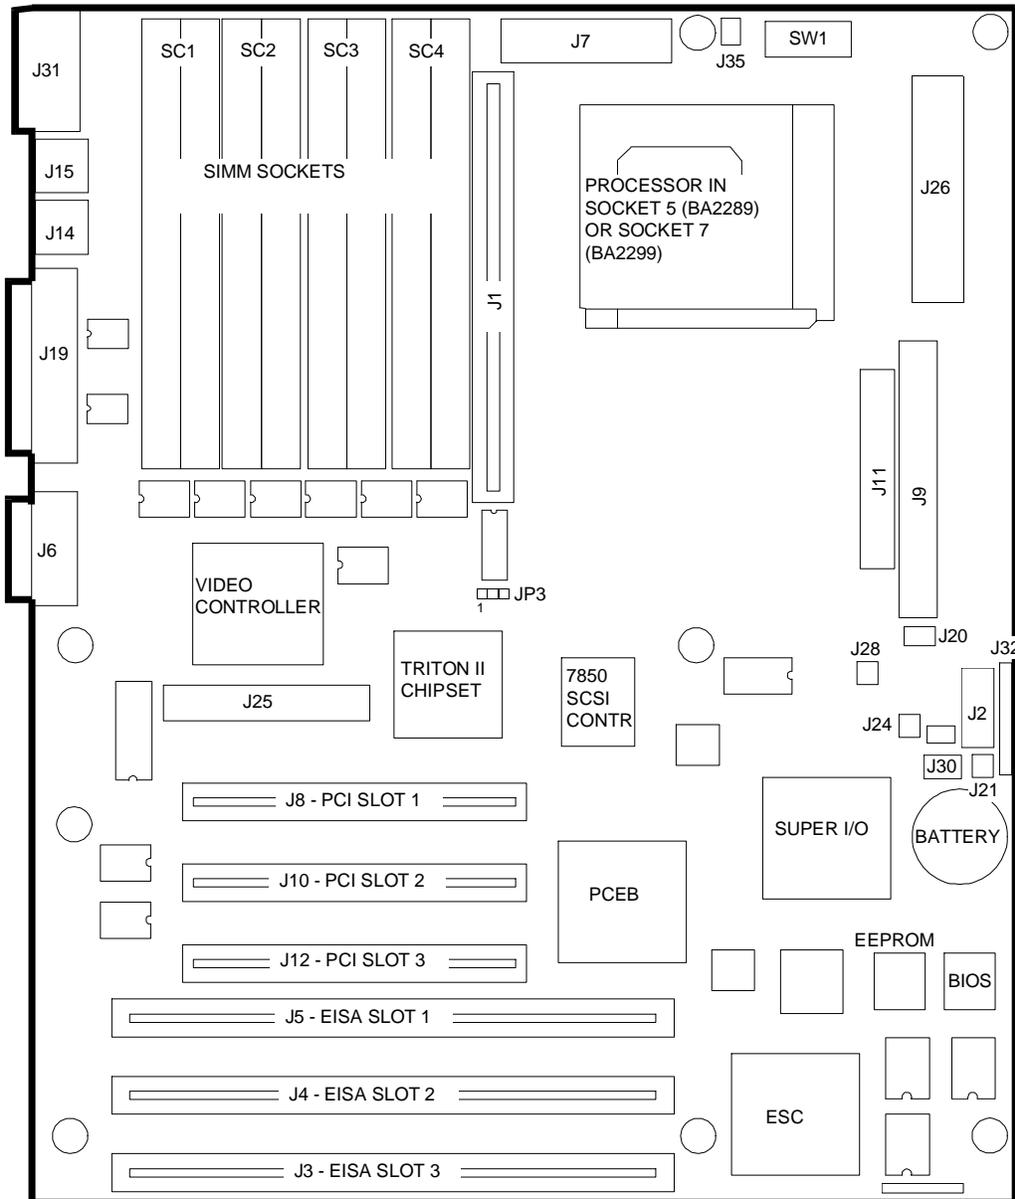
## MONOPROCESSOR MOTHERBOARD BA2289/2299 FOR THE SNX 140/S 100, 140/S 133, 140/S 166

| J6 | SVGA video connector (15-pin) | J25 | COM2 serial and parallel conn. (34-pin) |

DATE	LEV.	VIMO CODE	REASON FOR CHANGE	APPLIC.
05/96	Nasc	212712 X	New board to replace the BA2299. SAR board MI2117 is always plugged into this board, the processor is installed in Socket 7 and the Hobbes board socket is present.	Factory
6/96	01		New Intel Triton II step A2 (pos. U1) component to replace the step A1 version. The main feature of the evolution from step A1 to A2 is the SERR signal management for the ECC.	Factory
6/96	01S1		TGUI9440 Trident (pos. U15) video controller evolution from Rev. B to Rev. D.	Factory
9/96	02		AIC7850 (pos. U51) SCSI controller evolution from Rev. B to Rev D.	Factory
10/96	03		The system crashes during the OS/2 stress test due to chipset failure during arbitration. Replace the programmed EPLD "EAGLE2_C" (U33) Funt. N. WP75 with EPLD "EAGLE2_D" Funct. N. WP88.	Factory
12/96	04		Triton II chipset (pos. U1) evolution from step A2 to step A3.	Factory

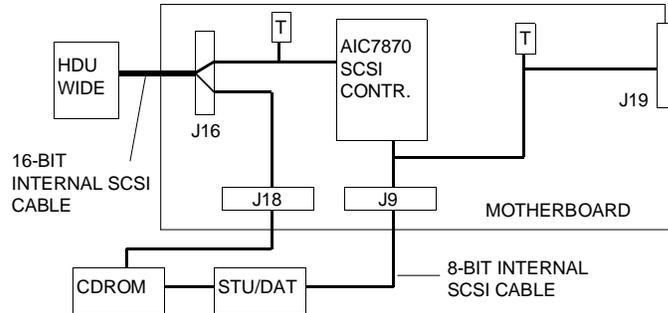
Connector J32 also provides the signals for the HDU activity LED on the console.

The following block diagram shows the SCSI channel path.

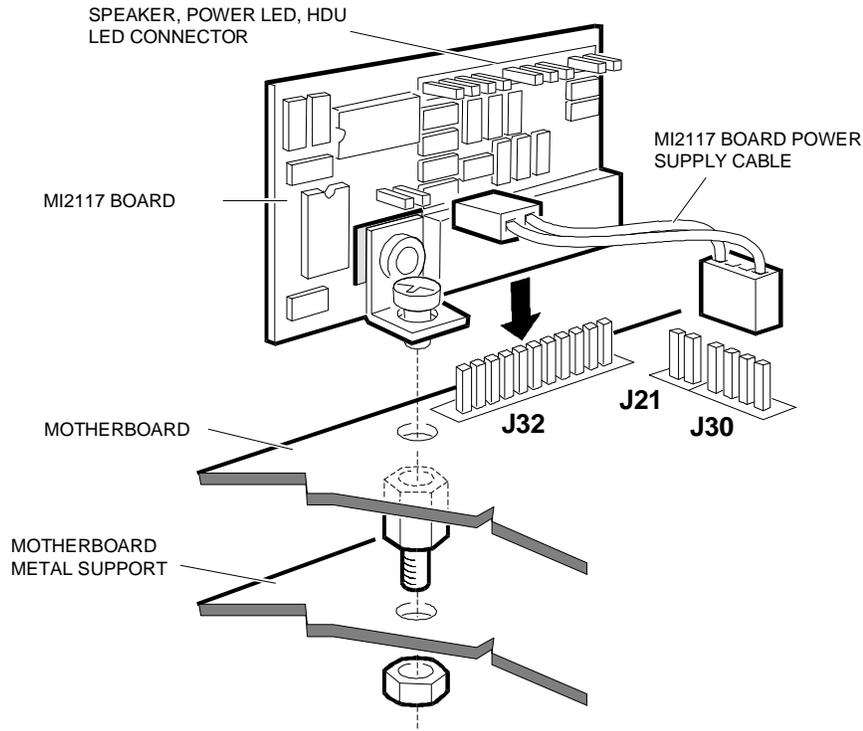
This board also gives hardware support to the system so that the SAR (Systema Automatic Restart) feature can be managed. This feature allows, following a system crash due to hardware or software failures, to automatically reset and reboot the system so that it becomes available once again within a short period of time without the user having to carry this operation out manually. The following items are required for this board to operate:

- Operating system capable of handling the SAR feature
- Server View or an operating system that allows the SAR to be enabled or disabled
- Motherboard hardware setting (SAR board + 2-8 minute counter)
- A BIOS capable of supporting this feature.

DATE	LEV.	VIMO CODE	REASON FOR CHANGE	APPLIC.
05/96	Nasc	212714 Z	New SAR board.	Factory
