SNX 160/RS NEW / 160/RM SYSTEMA (OLIMPUS)

CHARACTERISTICS

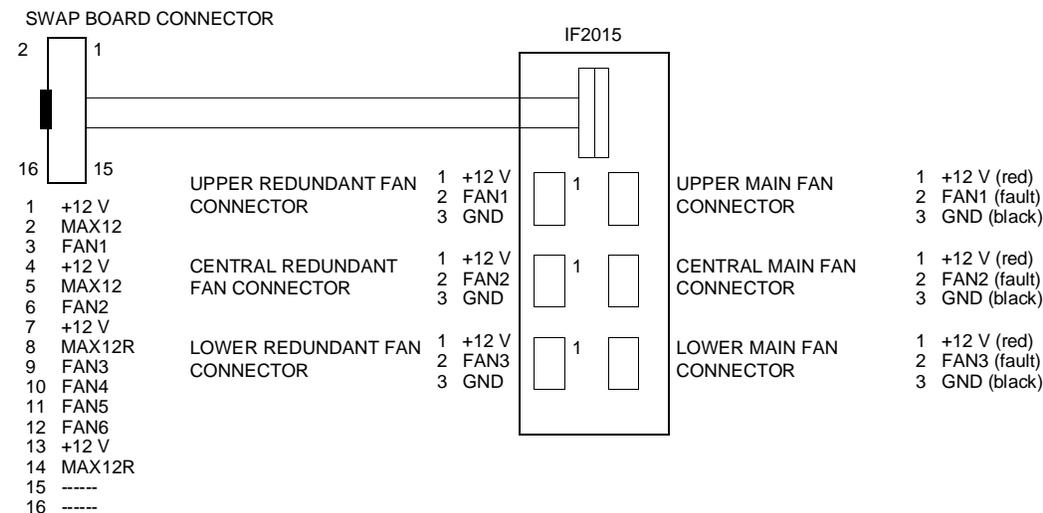
The main and redundant fans are always operational. When any one fails, the operator is informed so that the failed fan can be replaced with an identical one (B26). The three main fans are located towards the rear of the system (board area) while the redundant fans are located at the front.

The main and redundant fans are connected through the fan power supply distribution board IF2015.

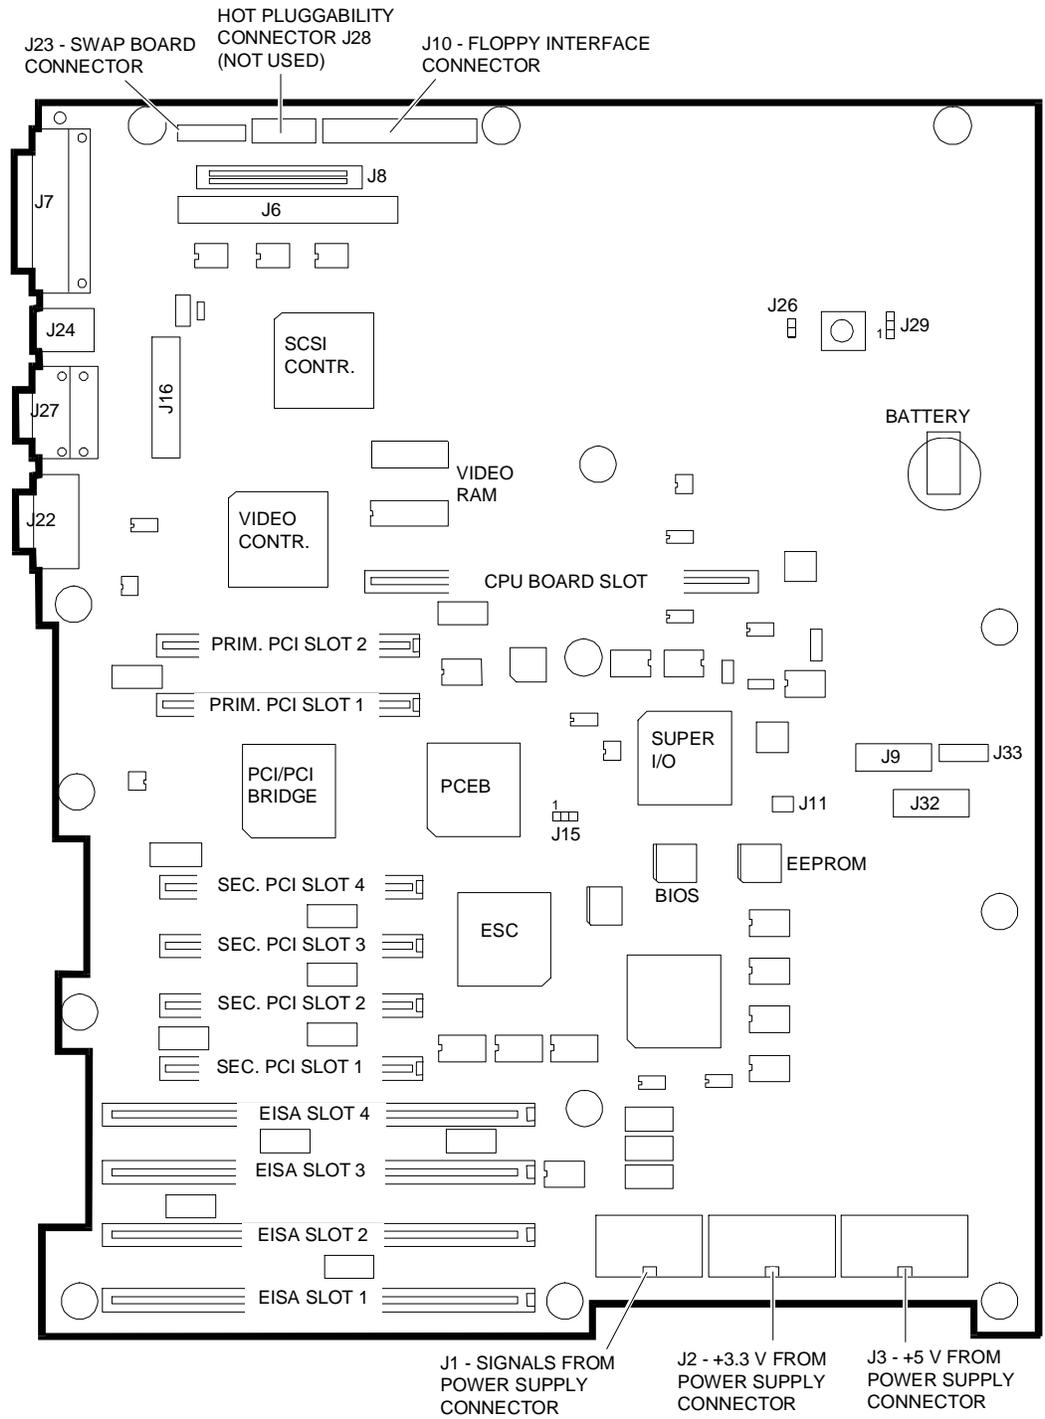
MOTHERBOARD BA2298

| <p>J7 Double connector:

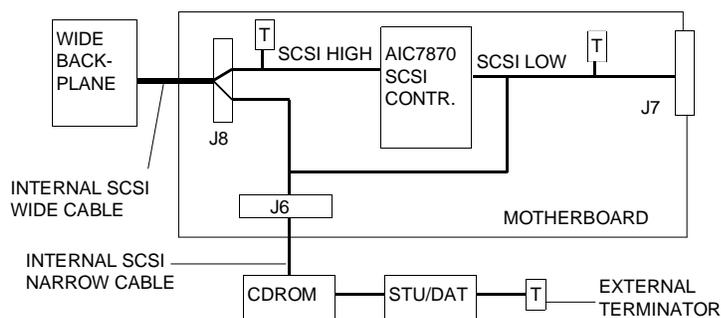
The following block diagram shows the SCSI channel path.

The rules for configuring the SCSI channel on the SNX 160/RS/RM NEW are described in Appendix J.

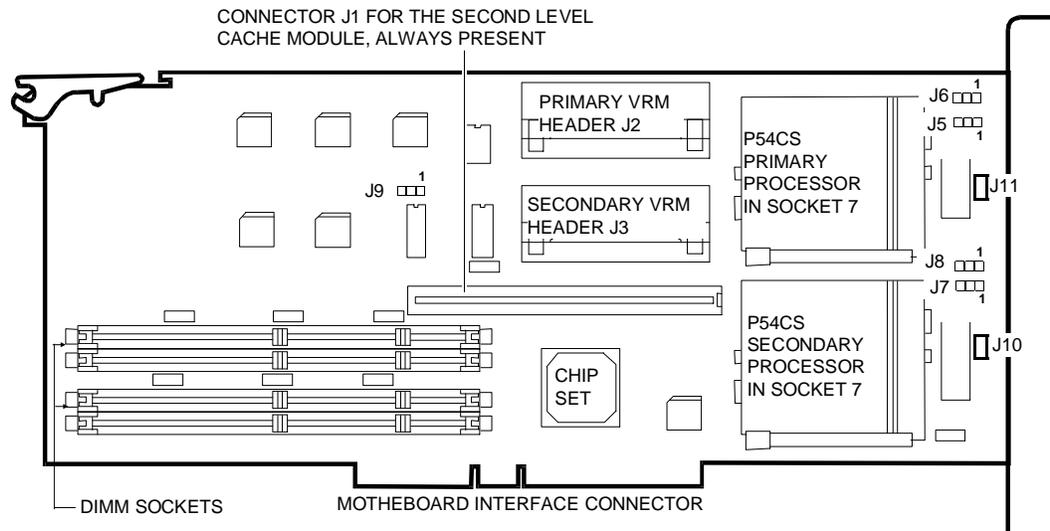
DUAL PROCESSOR CPU BOARD UC2010

Note: The name of board UC2010 remains the same for the versions equipped with a 133 MHz, 166 MHz or 200 MHz P54C processor.

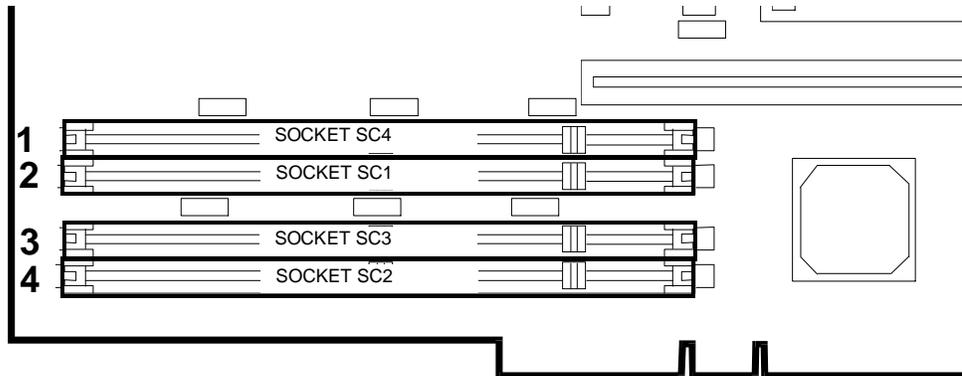
MEMORY EXPANSION DIMMs

The CPU board has four 168-pin sockets for the installation of 3.3 V DIMMs. The memory controller in the chipset supports fast page mode parity checking or ECC DIMMs, or no parity EDO or ECC DIMMs. The memory controller on these systems is programmed to support fast page mode DIMMs with ECC checking. When DIMMs are either installed or removed, simply power on the system again and run the ECU; there are no hardware jumper settings to be made.

- The system sees its memory as being divided into four banks (1, 2, 3, 4). Each bank consists of one socket on the CPU board. Bank 1, socket SC4; Bank 2, socket SC1; Bank 3, socket SC3; Bank 4, socket SC2. The DIMMs can also be installed individually.
- DIMMs of different capacity can be installed on the same board.
- The minimum memory configuration is 32 MB expandible to 512 MB.
- Always install the DIMMs starting from bank 1 and proceed in the following order: socket SC4, SC1, SC3 and SC2.
- The EXM 3V032 (4 Mbit x 72) DIMMs cannot be used with 3V064 (8 Mbit x 72) and 3V128 (16 Mbit x 72) DIMMs. There are no compatibility problems when using EXM 3V032S DIMMs.
