# M4-82 / PCS52 E

## CHARACTERISTICS

### MOTHERBOARD

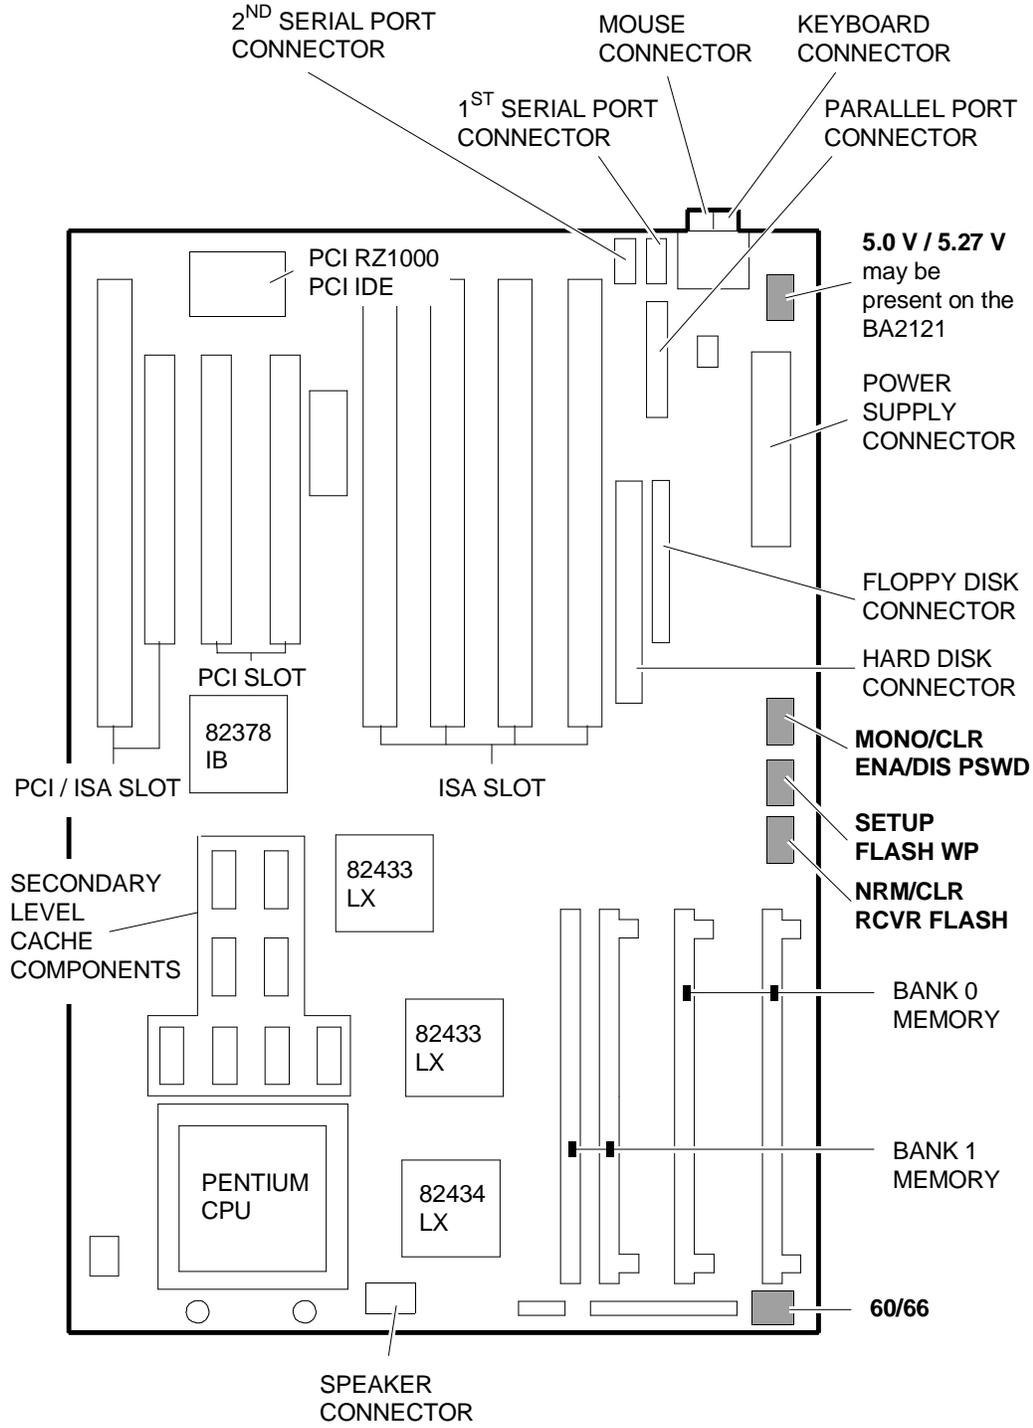
**COMPONENTS AND JUMPERS ON THE BA2066, BA2121 AND BA2147 MOTHERBOARDS**

**Jumper (60/66) - System Clock Selection**

**WARNING:**  
Use this jumper very carefully since its misuse could damage the system processor.

**Jumper RCVR FLASH - Enable BIOS Recovery Mode**

**Jumper NRM/CLR - Cancel CMOS**

The CMOS can be cancelled  
The CMOS cannot be cancelled \*

FLASH EPROM - Normal operation \*  
FLASH EPROM - Recovery Mode operation

**Jumper SETUP - Enable the Setup utilities**

**Jumper FLASH WP - Enable write to EPROM**

Access not allowed to the Setup utilities  
Access allowed to the Setup utilities \*

Flash EPROM cannot be updated  
Flash EPROM can be updated \*
